ENGINEERING DESIGN FILE

TSF-09/18 V-Tanks Remediation Pump Seal Evaluation

**Idaho
Cleanup
Project**

EDF No.: 6259

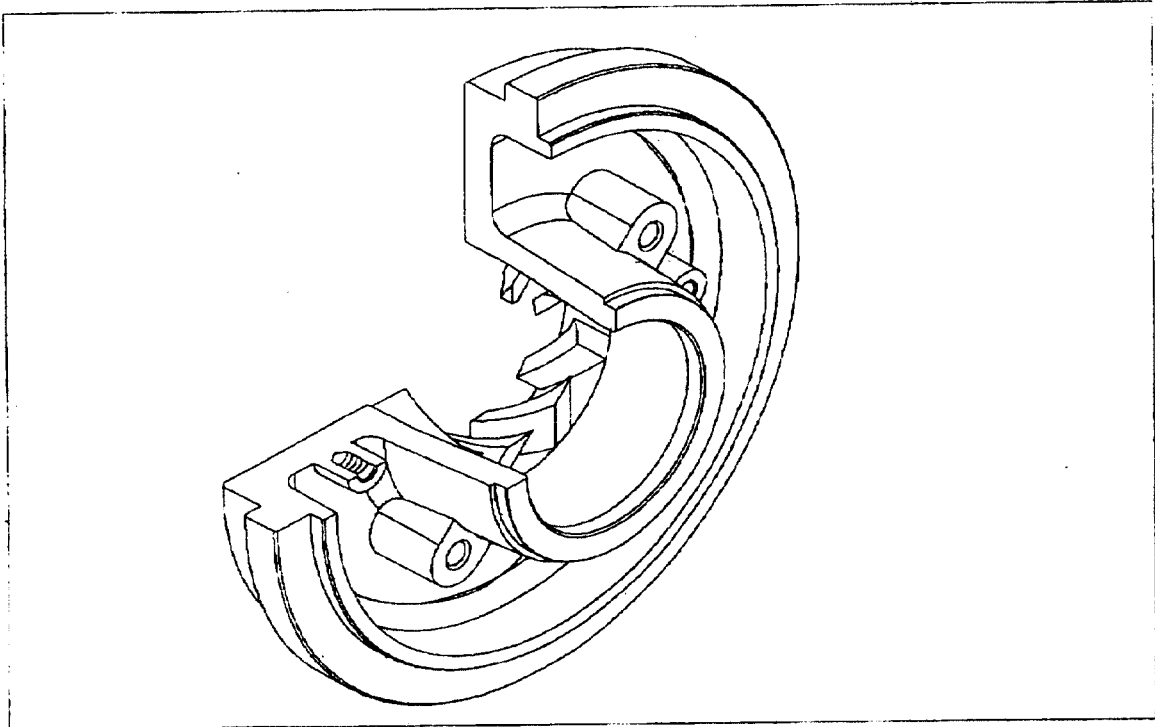
Figure 1

Item 4 listed above was identified as a potential problem, when P1 and P2 were disassembled for replacement of the failed seal. It was observed that a build-up of solid material had occurred in the area behind the pump seal chamber adjacent to the mechanical seal. The type

of seal chamber supplied on the pumps is a “Taper Bore” seal chamber (Appendix 1., Figure 1) which is generally used when pumping fluids with less than <10% suspended solid, which was the original design criteria for pump selection. However, actual fluid properties appear to have more than 10% suspended solids, in which case the recommended seal chamber is a “Big Bore” seal chamber (see Appendix 1., Figure 2 & 3) utilizing a machined bushing with 0.003 clearance between the shaft and the seal. A clean water flush is used behind the seal chamber to keep the solids from contacting the seal. Based on Appendix 1, Figure 4.37 the estimated water usage is:

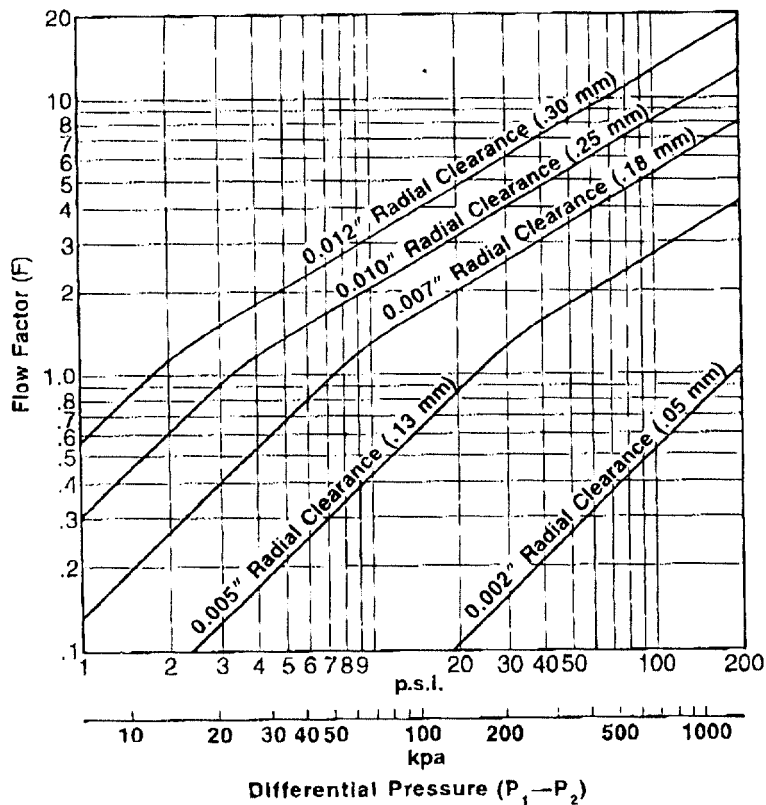
Figure 4.37 Flow Rates for Close Clearance Bushings

$$\text{GPM} = F \times L \times \text{O.D. (Shaft)} = (0.16) \times (1.4) \times (1.75) = 0.39 \text{ gpm}$$

F = flow factor from graph (0.003”)	= 0.16
L = bushing length factor	= 1.4
O.D.	= 1.75

However, based on the current mode of operations and the solid(s) content of the fluid, it is recommended that centrifugal pumps P-1 and P-2 be replaced with a more robust pump. The high solid content of the slurry lends itself to slugging which most likely has damaged pump P-1 and P-2. The seal flush system for the centrifugal pumps as discussed is not feasible due to the amount of water usage.
